# UNESCO

## Refurbishment of an occupied heritage office building.

# An improved and strengthened façade concept

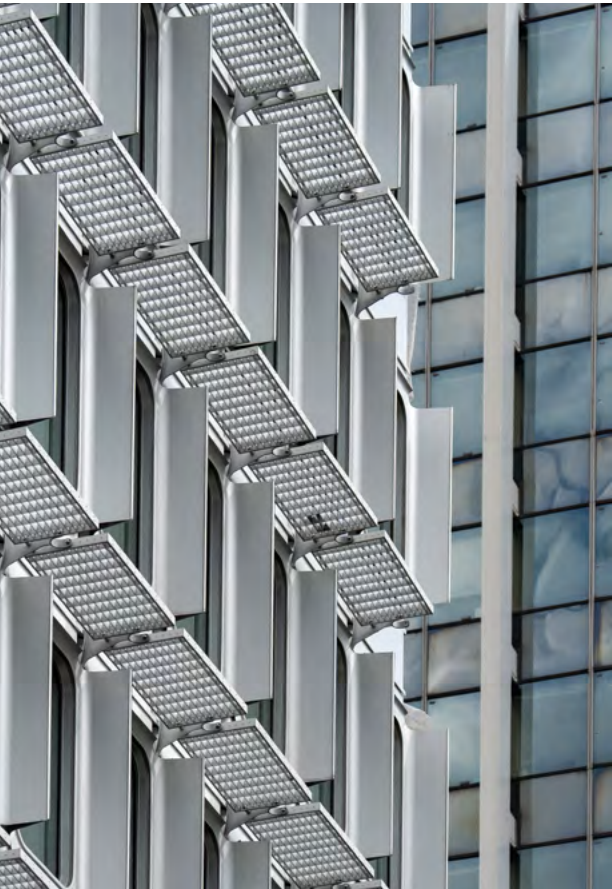
Solar gain is one of the main contributors to heat in buildings, and has a direct impact on comfort and the energy requirements of the cooling system. By analysing solar irradiation, it is possible to assess the effectiveness of solar protection. The west facade was particularly exposed. Through refurbishment, solar radiation was reduced by 13%.

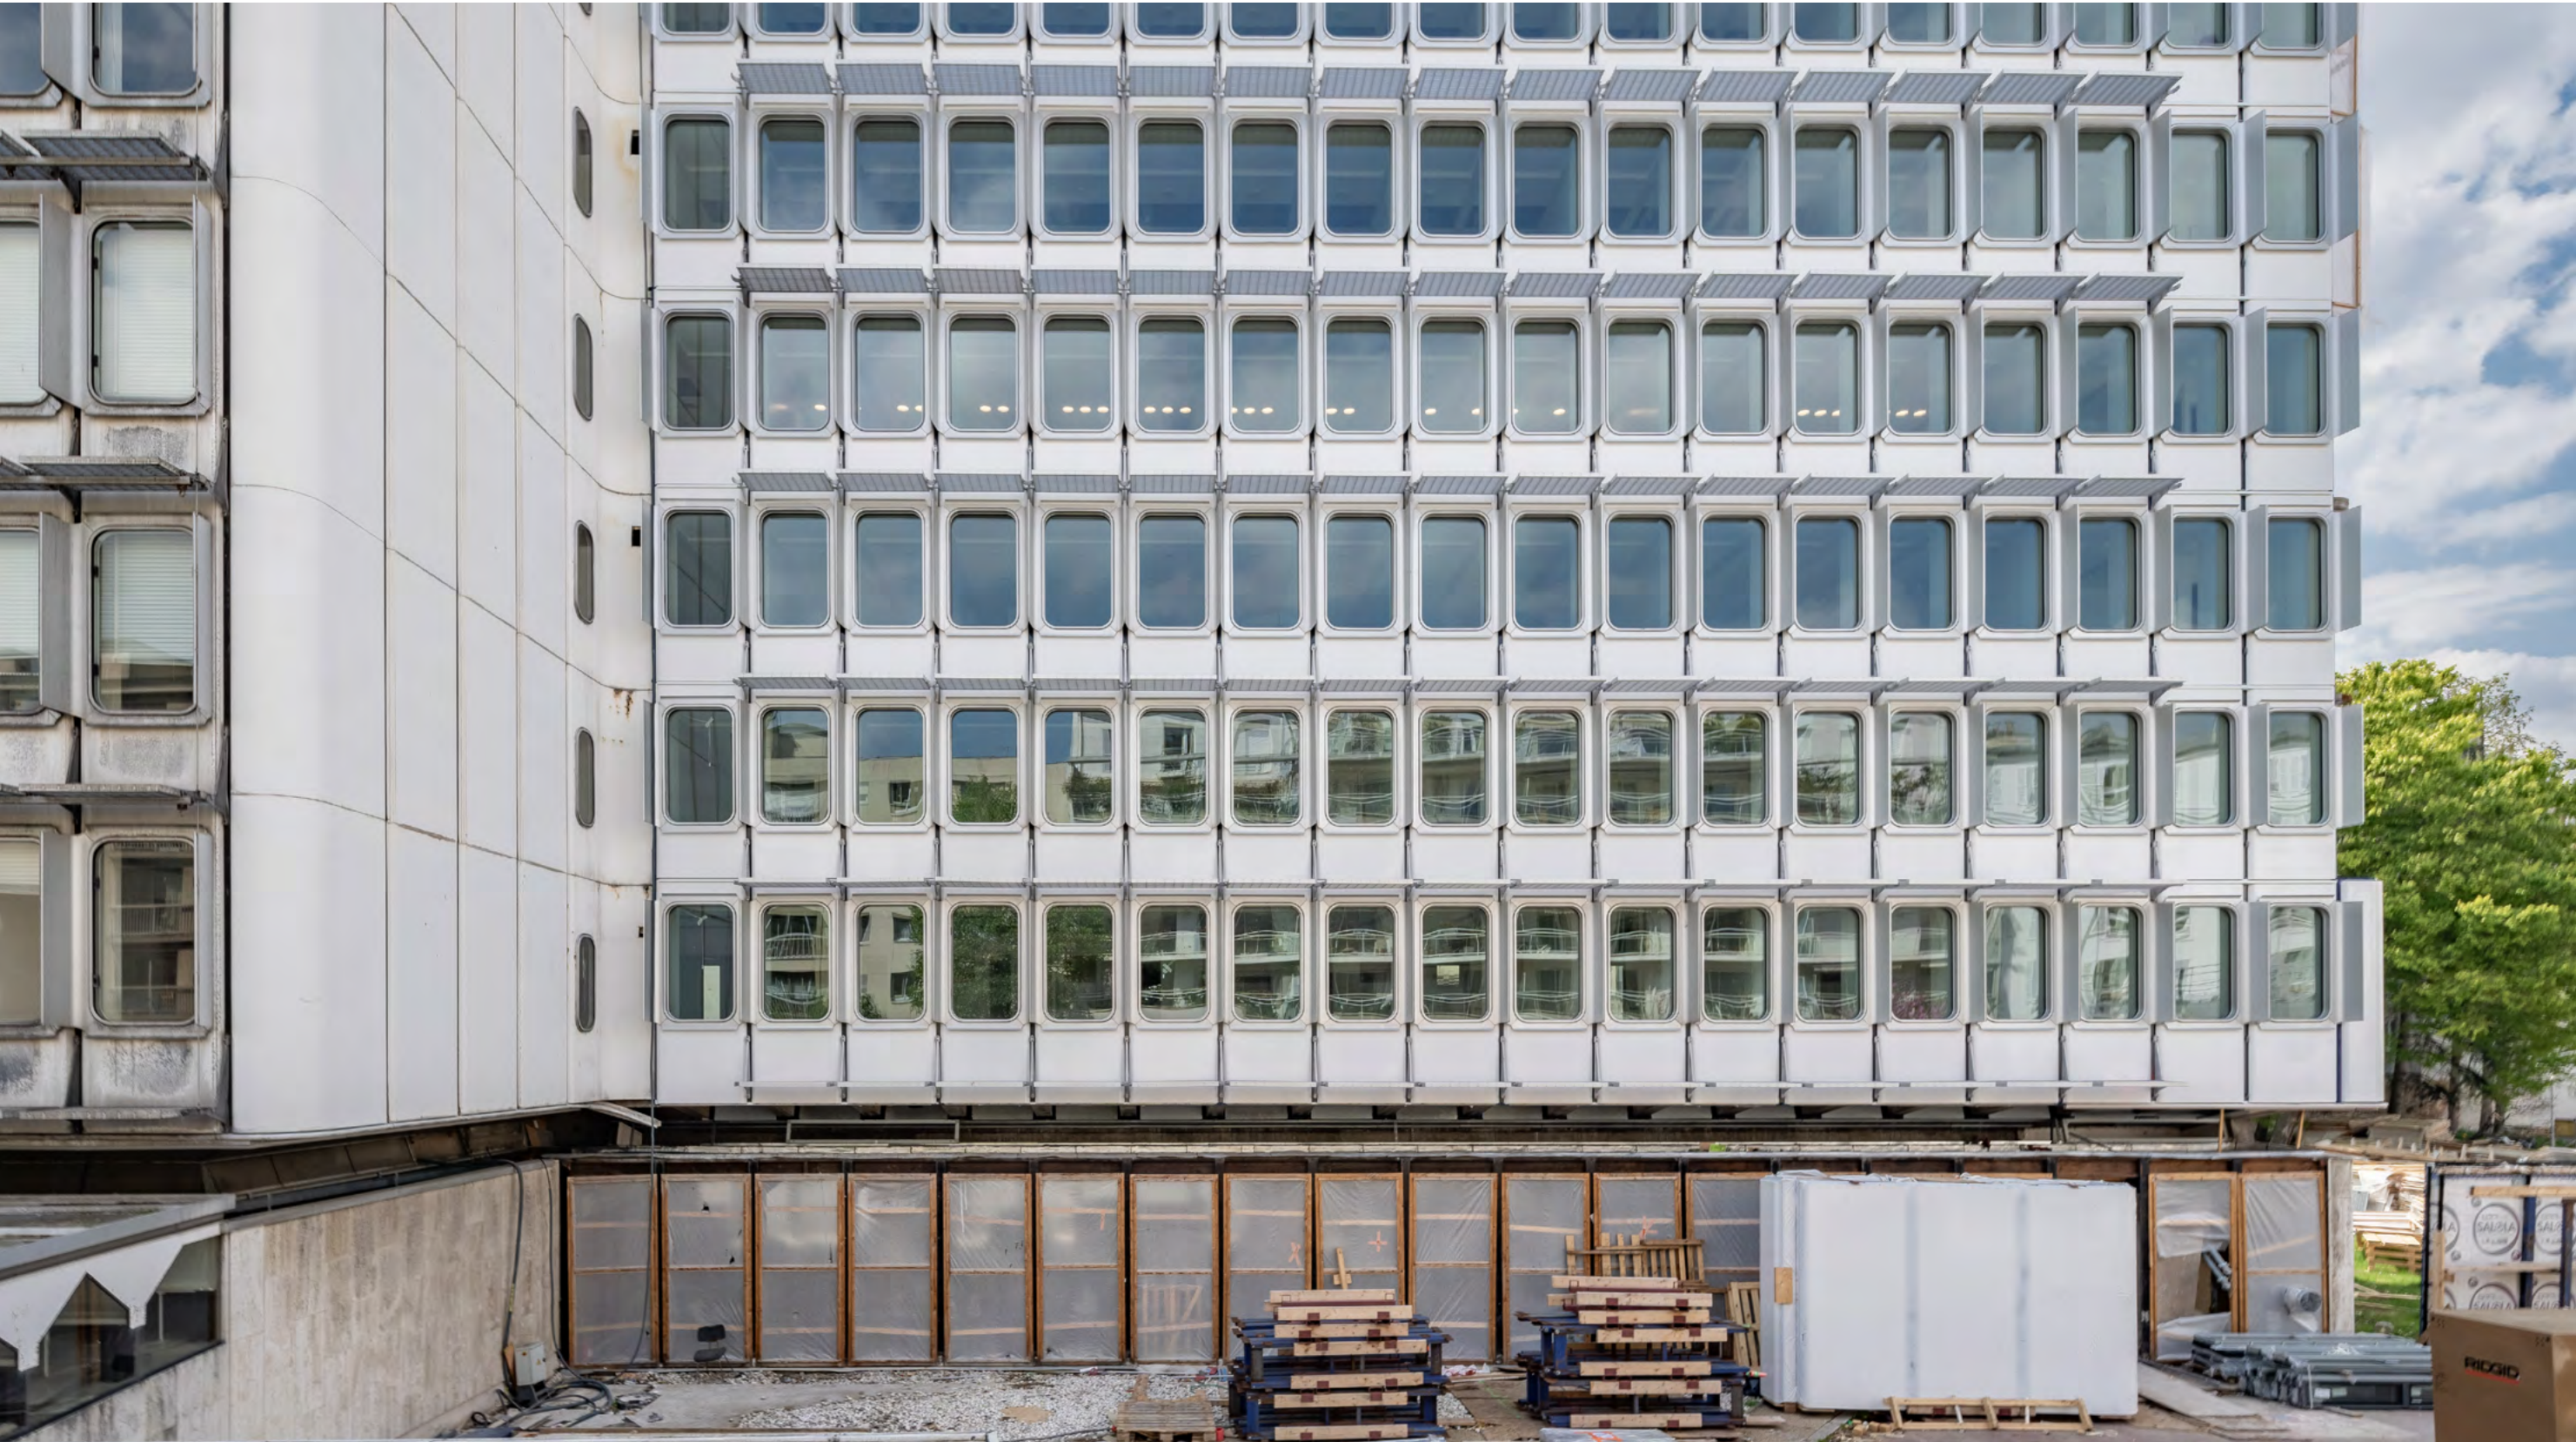
The results show the cumulative solar energy per unit area (kWh/m2) over an entire year. They are visualised in a colour gradient on the 3D model of the building and can be interpreted as follows: blue indicates low exposure, green/yellow areas acceptable solar gain, and orange/red, walls receiving a large amount of heat.
